Dreux A. Seghers, P.E., LLC

September 5, 2025

Re: Residential Property – Construction Evaluation
Homeowner: Mr. and Mrs. Yuri Petrini
Subject: Report of Findings

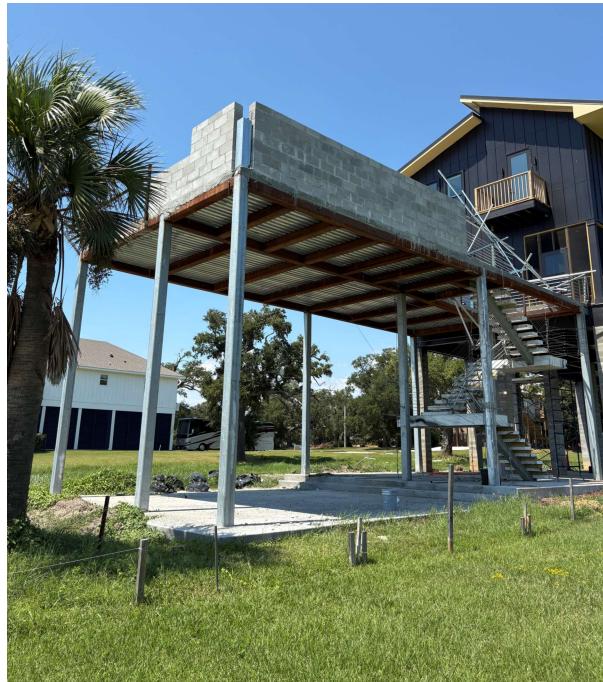
Front or south elevation showing the structural pool deck

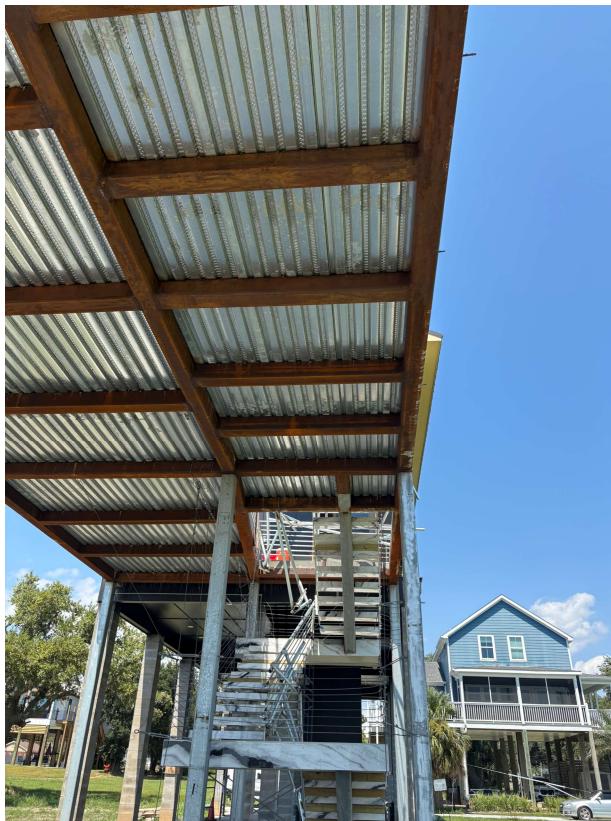
5. The upper pool deck consists of a composite metal pan and steel-reinforced concrete deck system which provides a rigid diaphragm to the moment frame mentioned above. This provides greater resistance to lateral bending.

View of Structural Decking showing columns, beams and concrete deck pan

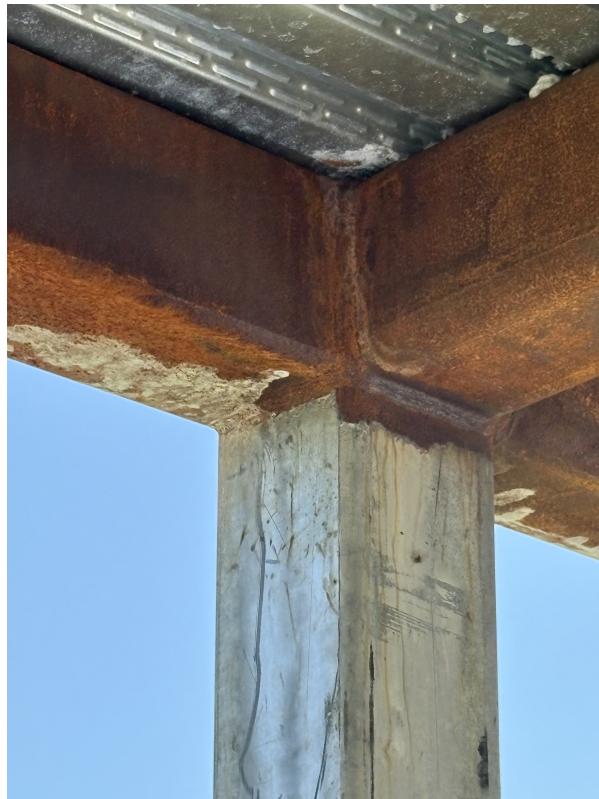
3. The steel HSS column and beam frame for the pool deck is welded together at all joints providing a rigid joint connection or a moment frame. This design type is more resistant to bending than a bolted or pinned joint connection frame.

View of Structural connection at columns to beams denoting a moment frame

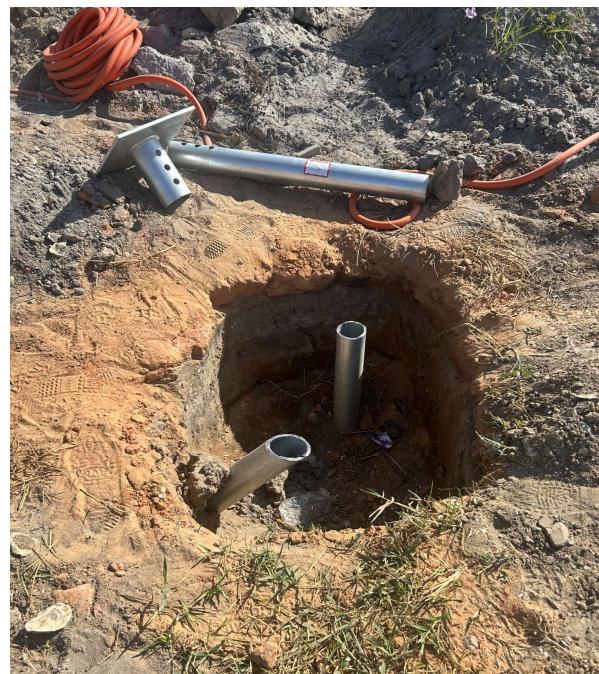
View of top of helical pile shafts. Vertical and batter pile shafts shown

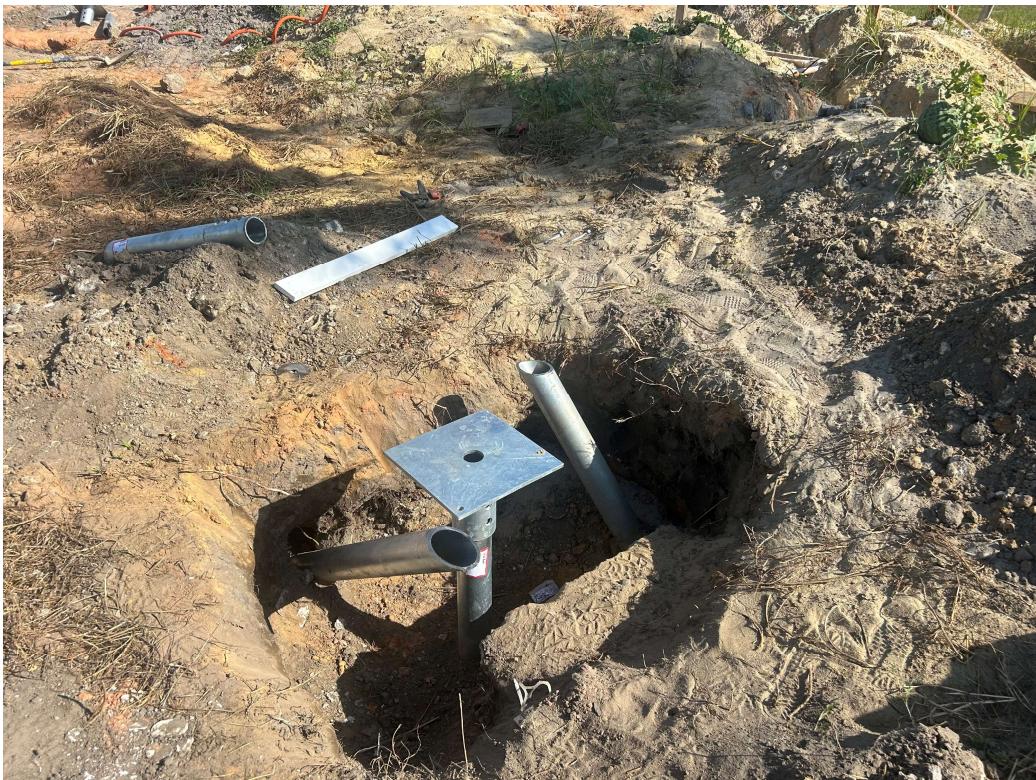
From this statement, I assume that this refers to the helical pile positions under the HSS steel columns. From my review of the as-built drawings and photographs, I observed that the 8" square HSS columns were welded to the standard 12" square helical pile cap plate that are supplied with the helical piles. The steel top plate is part of a proprietary system that includes a receiving cup or sleeve located directly in the center of the bottom of the steel plate. Therefore, the plate will be centered directly on top of the helical pile shaft. From my review of the construction photos, I was able to observe that the HSS columns were welded to the 12" square plates and generally centered within the plate. Of note, I did observe that the columns were slightly off center on the plate but still located over the helical pile shaft. This off-center condition is called eccentric loading and I asked Mr. Petrini to analyze this condition using ETABS software. I was provided this

From my review, I was unable to find where the columns did not get installed (welded) generally near the center of the base plate. I did find some small offset (eccentricity) with the columns to the base plate which appeared to be less than 2" in either the N-S or E-W direction. However, the helical pile shaft and top plate are embedded in concrete providing resistance to potential bending from an eccentric load. Further a structural analysis was performed using ETABS structural software and determined that the eccentric loading was safe.

View of top of helical pile shafts with proprietary top plate for connection to columns

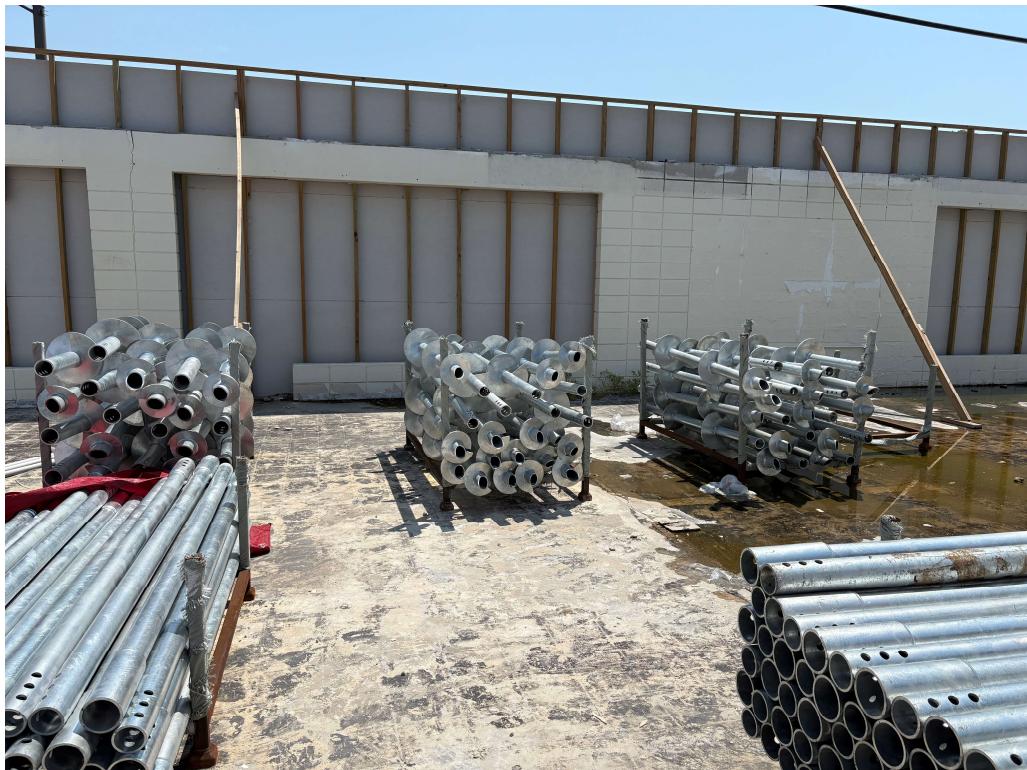
View of helical piles and shafts at the Bohn St warehouse

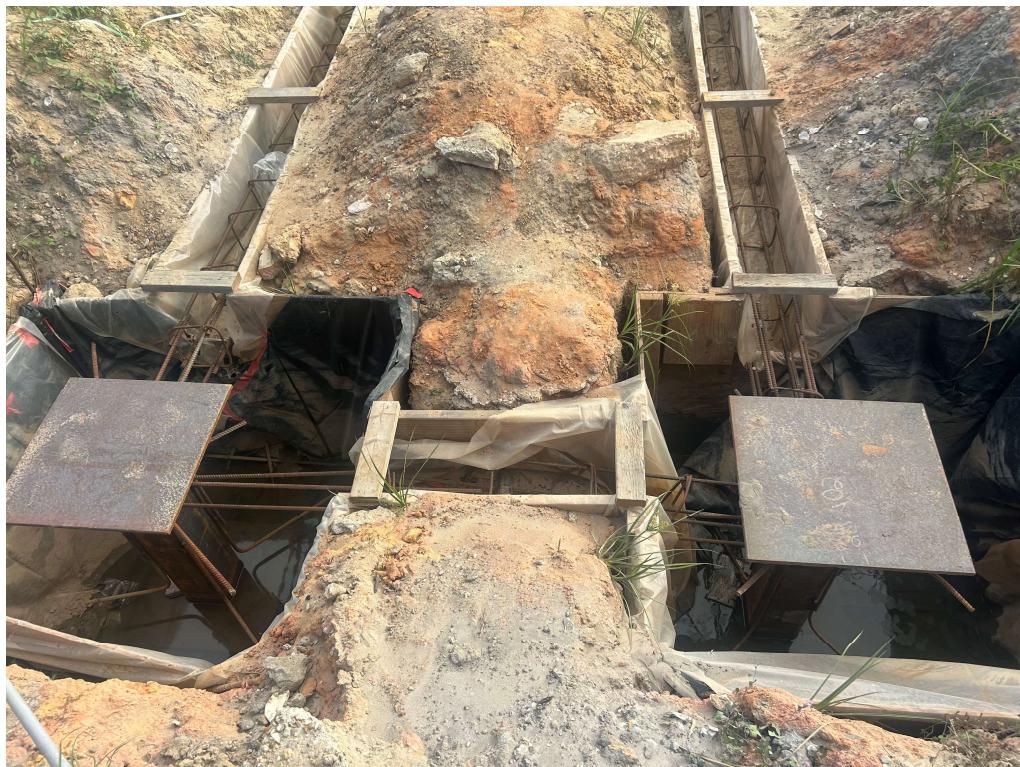
In addition to the helical pile and top plate, the top of the helical pile was embedded in a steel-reinforced concrete footing to provide additional load transfer and lateral support. There is also a grade beam that structurally connects the adjacent pile cap. From my review, the helical pile installation is in accordance with generally acceptable installation methods. And according to the structural analysis software, the helical piles provide acceptable load resistance.

I was unable to verify that the pile caps were less than 24". From my review of the photographs, I saw that the concrete pile caps were visually 24" square and 24" deep. Additionally, there is a 4" cap or topping slab on top of the cap.

View of top of large footing under pool column showing embedded plate pedestal and grade beams
